OTHER FARM BUILDINGS

Granaries and Elevators

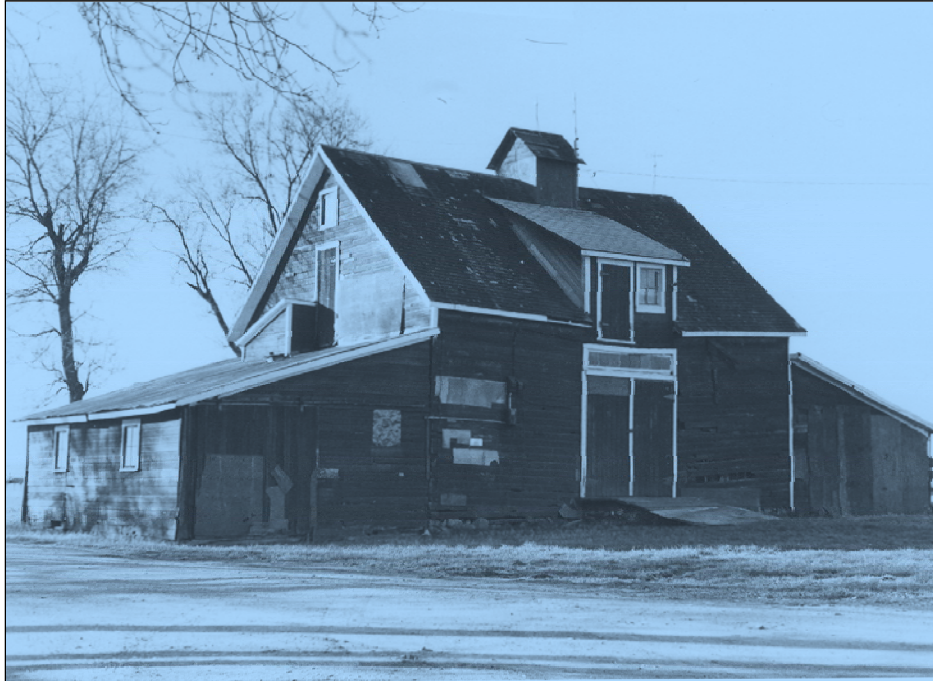
Figure 62

Low Granary, NE 32-9-19W, 1892. The simple drive-in granary was altered by the addition of a small belt-driven bucket elevator, whose distribution head projects through the roof, a small feed mill and shed-roofed storage areas on each side.

Larger granaries were slightly more complex. Instead of wagons pulling alongside the building and bags being pitched through a small door, wagons were pulled into an alleyway in the granary. From here, loose grain could simply be shoveled into high-walled bins on either side of the alley. A granary at NE 32-9-19W, built in 1892, shows this development (Figure 62).

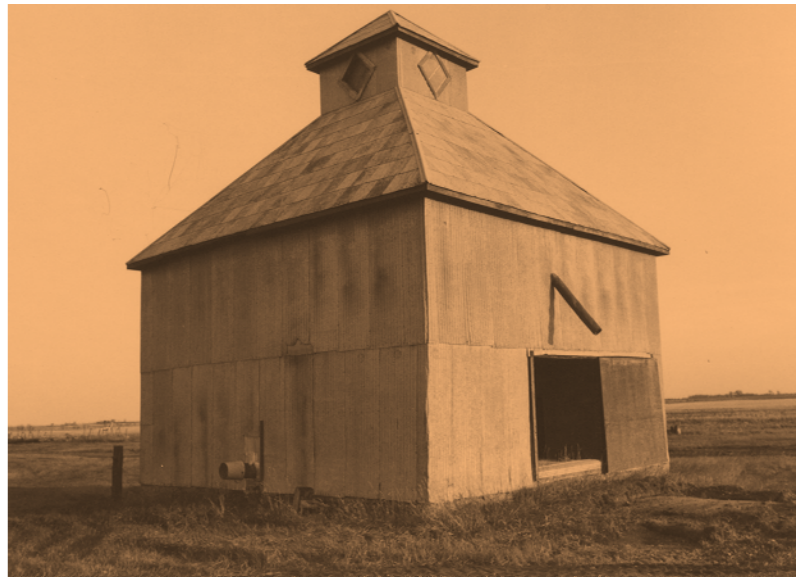
Figure 63
McCallum Elevator, NW 3-11-18W, 1904.
Grain was retrieved from the spouts that project from the walls.

Grain elevators began to replace the simpler granaries, particularly in south central Elton, around the turn of the century. While the two earlier types of granary relied on manual labour, grain elevators contained a system that mechanically distributed grain to the bins. A leg, which consisted of a series of small buckets attached to a vertical conveyor belt, lifted the grain up to a distribution box where it was dispersed to the individual bins. The McCallum elevator, built in 1904 at NW 3-11-18W, was a particularly good example of a grain elevator (Figure 63). A central corridor separated the building into two storage areas that were each subdivided into three bins (Figure 64). The capacity of the individual bins was 43,640 liters (1200 bushels). Above the alley were located two smaller slant-floored bins (Figure 65). The capacity of the west bin was 15,550 liters (400 bushels), while the east bin could hold 9090 liters (250 bushels). Wagons were pulled up the west door where grain was dumped into the lower grain box. From there it was lifted up the two elevator legs to the distribution box. Spouts connected to the distribution box directed the grain into one of the eight bins.

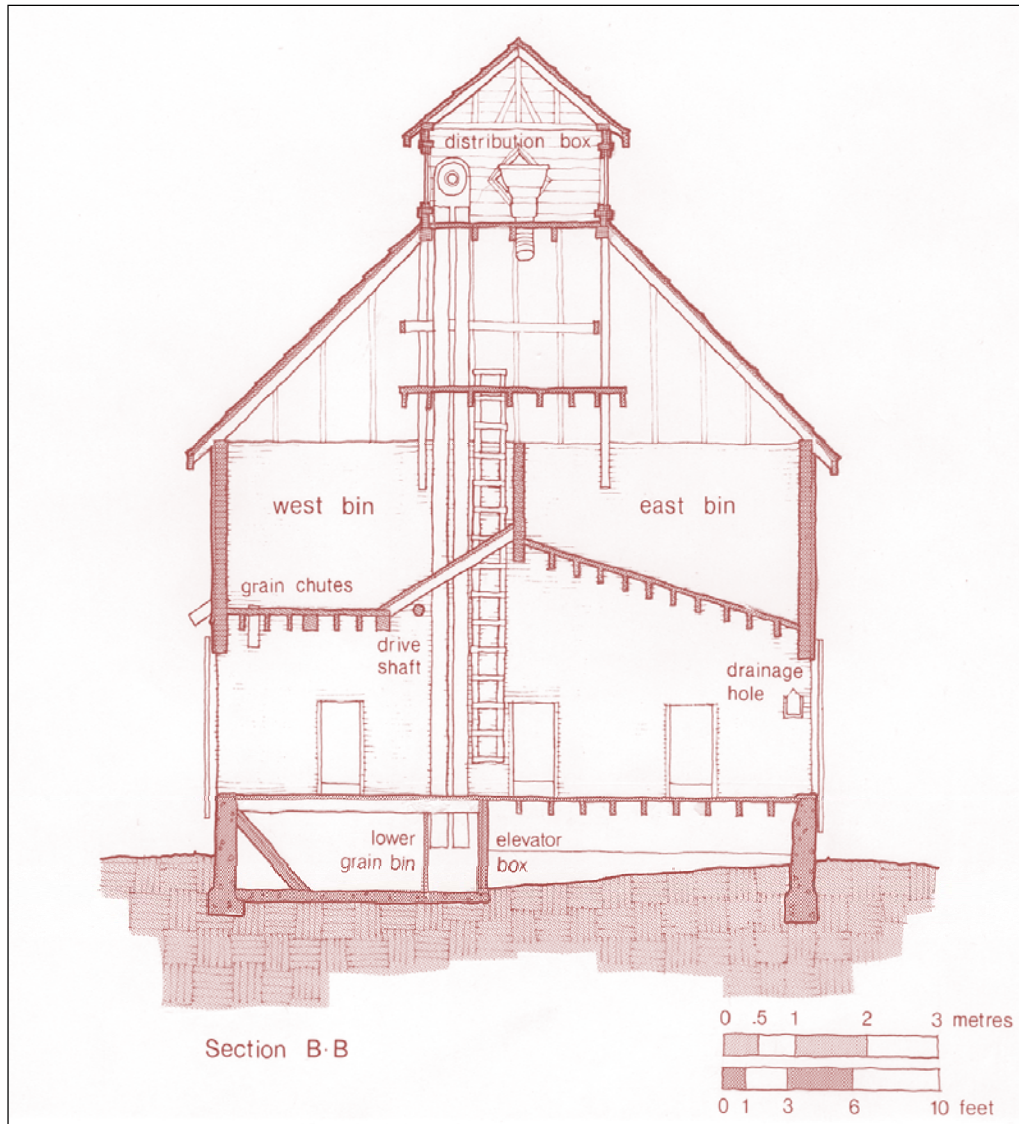
Figure 65
McCallum Elevator: section. The capacity of this elevator was 68,280 litres (7850 bushels).
